Modern Accident Investigation

A MODERN ACCIDENT INVESTIGATION

DON J. FINNEY†

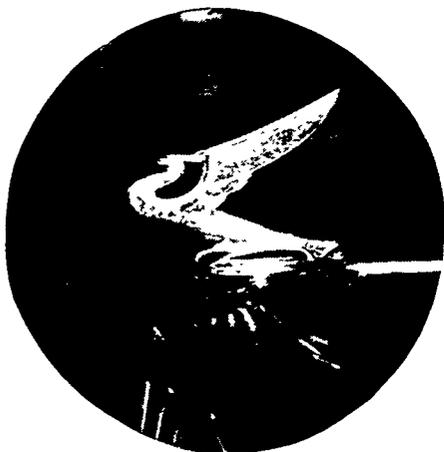
FIGURE 1
View of broken ornament on
"hit-and-run" car.

The broken beak was photographed in its original position on the ornament. Enlargements were made to illustrate the matching of the broken edges on all sides.
