Comparison and Identification of Wire in a Coal Mine Bombing Case

Charles M. Wilson

THE COMPARISON AND IDENTIFICATION OF WIRE IN A COAL MINE BOMBING CASE

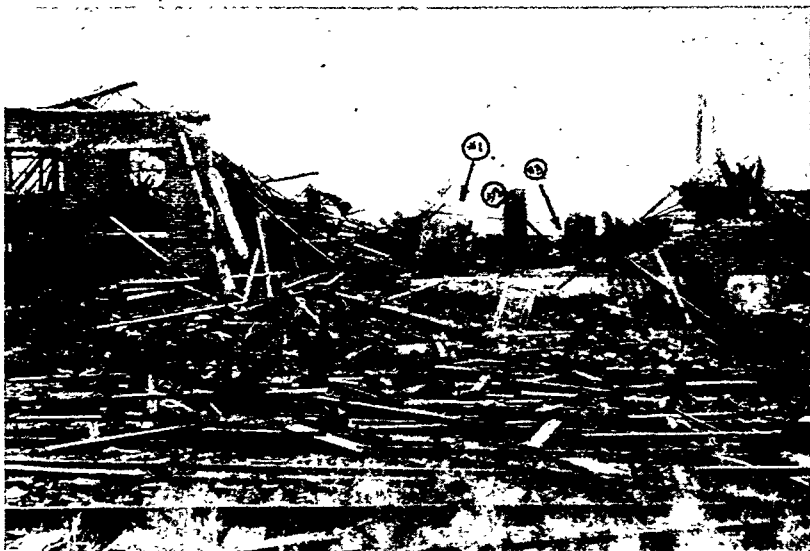
FIGURE 1

Remains of power house of Valier Coal Mine. West wall in foreground. No. 1 locates position where alarm mechanism was recovered (on east side of generator). No. 1 and No. 3 locate motor-generator illustrated in Figure 3, infra.

The scene of the explosion was carefully examined by two members of the Laboratory Staff³ and a number of photographs taken of the remains. (See Figures 1, 2, and 3.) Two additional dry cells and several small brass gears were discovered, which were later found to have originally been part of the alarm clock recovered by the Sheriff. These articles were located in the generator pit at the entrance to a duct or conduit (Fig. 2, No. 1) through which the cables ran under the floor to the switchboard located on the east wall of the power house.⁴

(Editor's Note: At the trial of this case the photographs shown in Figures 1, 2, and 3, which were taken by Mr. Wilson, proved to be extremely valuable to the prosecution for the purpose of establishing the fact that a "high" explosive had been used and that therefore the damage could not have resulted from a "low" explosive with coal dust or gases as the causative agents. Dr. C. W. Muehlberger, the author of the articles referred to in footnote 6, utilized the photographs as the basis for his testimony that the effects of the explosion, as illustrated by the photographs, identified the causative agent as a "high" explosive.)
